Technical Service Bulletin

GROUP CAMPAIGN	NUMBER 18-01-005-G
DATE DECEMBER, 2018	MODEL(S) G70 (IK) G80 (DH) G90 (HI)

SUBJECT: 19MY GENESIS G70 (IK), G80 (DH), G90 (HI) BRAKE PULSATION (SERVICE CAMPAIGN T06G)

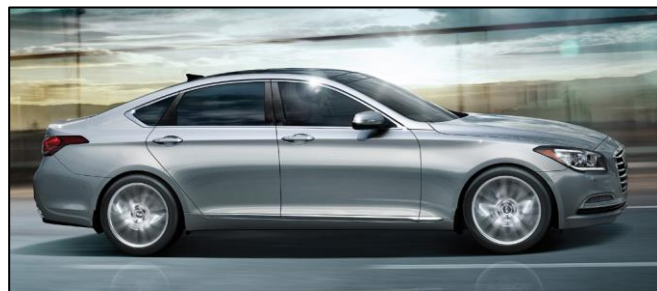
1. Drive the vehicle and accelerate to 50 mph.

Apply the brakes using moderate force (about 0.3g deceleration rate) and slow the vehicle to 10 mph. *This will take about 6 seconds.*
