Technical Bulletin

46 11 06 April 18, 2011 **2015173** Supersedes T. B. V461005 dated October 25, 2010 to remove Canadian market and include additional models and model year applicability.

Brake Disc, Pulsation, All Vehicles except Routan (U.S. Only)

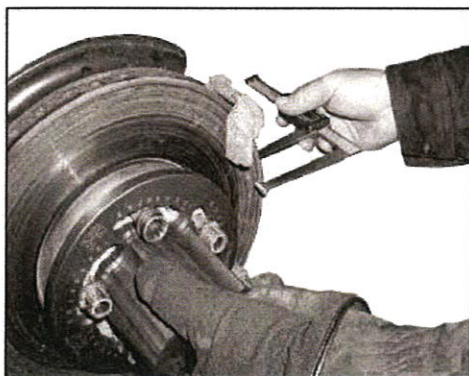
- Inspect brake disc friction surfaces on both sides of the brake disc for:
 - Severe discoloration (bluing)
 - High heat surface damage (raised hard spots)
 - Visible cracks

Brake discs showing any of the above described conditions **MUST** be replaced.

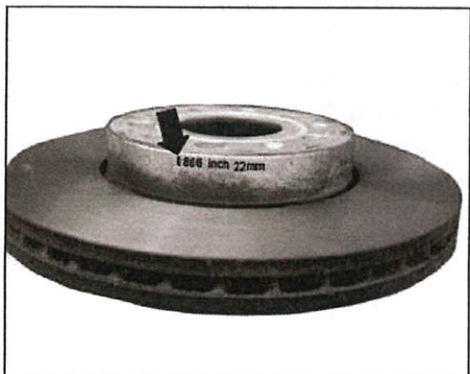
Each brake disc has the minimum allowed thickness cast, stamped or laser-etched into the disc hub.

- Measure the brake disc thickness in 4 locations using either the Pro Cut International™ disc thickness measuring tool Part No. 50-902 or the Hunter Engineering Company disc thickness measuring tool Part No. 25-99-2 . Measurements **MUST** be taken the same distance from the brake disc outer circumference to ensure consistency.

The brake disc must exceed the minimum thickness after the machining process is completed in order to be reused.

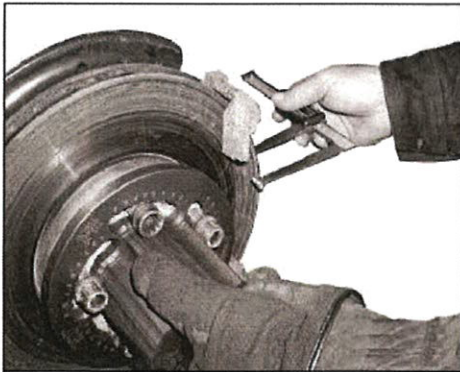
- Re-measure brake disc thickness in 4 locations using either the Pro Cut disc thickness measuring tool Part No. 50-902 or the Hunter disc thickness measuring tool Part No. 25-99-2, to verify that minimum thickness is still exceeded. If recorded brake disc measurement is less than the minimum thickness, the brake disc **MUST** be replaced.

Always replace brake discs in pairs (front axle and/or back axle).

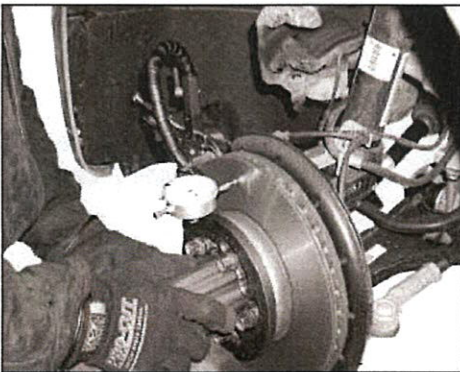
- Measure brake disc lateral run out using Pro Cut Disc Lateral run out measuring kit Part No. 50-700FC or the Hunter Disc Lateral run out measuring kit Part No. 25-128-2 with a dial indicator.
- Run out must not exceed 0.1mm.

Vehicles after 12 months / 12,000 miles in service are not eligible for brake disc machining. For brake vibration complaints on these vehicles the brake discs may be replaced if the lateral run out exceeds 0.1mm
