Technical Bulletin

46 11 06 April 18, 2011 **2015173** Supersedes T. B. V461005 dated October 25, 2010 to remove Canadian market and include additional models and model year applicability.

Brake Disc, Pulsation, All Vehicles except Routan (U.S. Only)

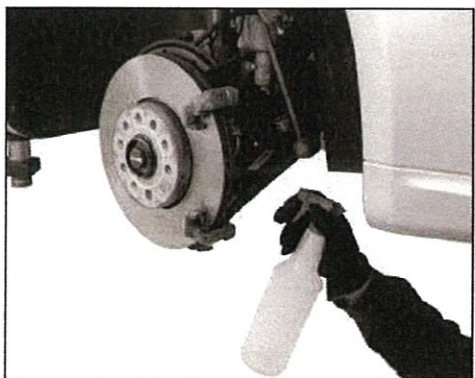
Recommended on-car brake lathes are either the PRO-CUT International™ PFM 9.0, or the Hunter Engineering Company model OCL 400. This design of brake lathe will produce a surface quality which will provide proper brake performance without a brake pad to brake disc break-in period.

To ensure that a high quality brake disc finish is produced, brake lathe cutting tools must be maintained as directed by the lathe manufacturer.

- Follow the brake lathe manufacturer's instructions for set-up and machining.
- Wash the brake disc with a soap and water solution upon completion of resurfacing to remove all machining particles.
