**NUMBER:** 05-002-13

Front Brake Judder And/Or Vibration

2011-2012 (RT) Caravan / Town & Country

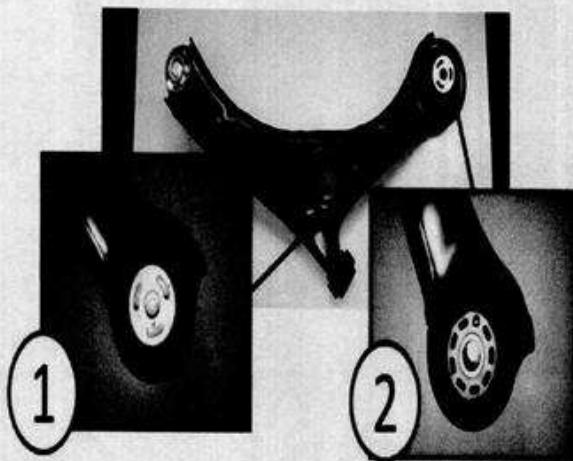
**Fig. 1 Front Lower Control Arm**

6. Remove and replace the right and left front brake pads. Refer to the detailed removal/installation procedures available in DealerCONNECT > TechCONNECT under: Service Info > 05- Brakes > Brakes, Base > Hydraulic/Mechanical > Pads, Brake, Front > Removal.
7. Inspect the bushing on the right and left lower control arm as show in (Fig. 1). Did the bushing have 8 slots as shown in call out 2 as compared to 3 in call out 1?
  - a. Yes >>> Return the vehicle to the customer.
  - b. No >>> Proceed to Step #8

- 1 - Replace Previous Control Arm Bushing (Metal Substrate Inner)
- 2 - Retain Current Control Arm Bushing (Plastic Substrate Inner)

8. Remove and replace the right and left lower control arm. Refer to the detailed removal/installation procedures available in DealerCONNECT > TechCONNECT under: Service Info > 02- Front Suspension > ARM, Lower Control > Removal/Installation.
9. Road test the vehicle for 5 miles.
10. Did any brake pedal pulsation, steering wheel shake and/or floor pan vibration exhibit.
  - a. Yes >>> Continue further diagnosis.
  - b. No >>> Return the vehicle to the customer.
11. Return the vehicle to the customer.
